UltraView

ULTRASOUND CAMERA

ue
SYSTEMS INC
The *ultrasound* approach

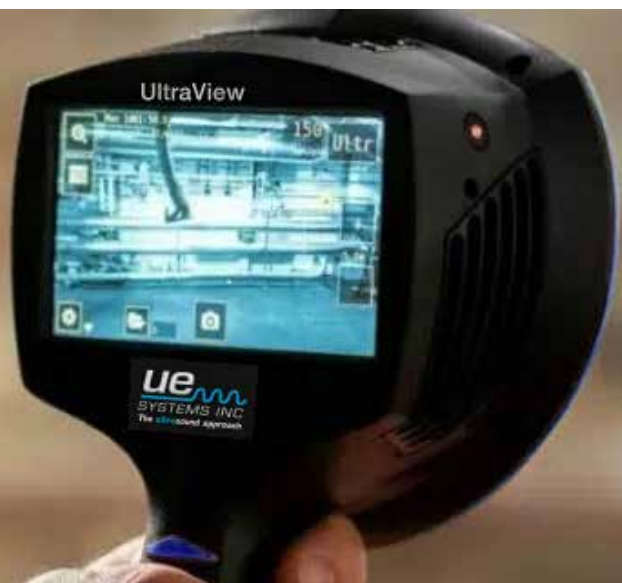
With the UltraView you can **easily find compressed air leaks (or any other compressed gas)**. Simply switch on the camera and watch how the leak locations show up on the screen. In a short time you will be able to cover a large area and find a significant amount of leaks, even at a safe distance.

For each compressed air leak the UltraView will show you the decibel level, the leak rate and the estimated leak cost. This way you can **have a quick overview of how much these leaks are costing per year** – and you will be surprised by how much they can cost! You can also store all your detected leaks and create an extensive leak report. The UltraView provides a quick and significant return on your investment. Capture, download & analyze sound files, just like on the Ultraprobe series of instruments. Integrate into existing UE Systems software including the SideKick App.

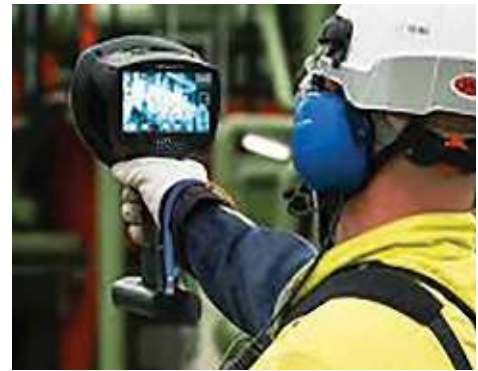
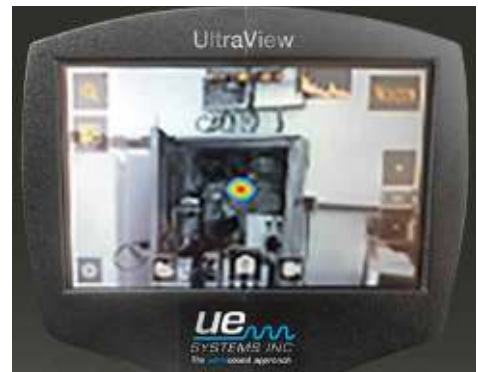
With the UltraView you can **save money by avoiding expensive downtime and guarantee the invaluable safety of your personnel.** Easily and efficiently detect issues such as corona, tracking and arcing. Just point the camera at any electrical asset and the partial discharge locations will show on the screen. The camera can even distinguish partial discharge from other ultrasound sources, reducing the number of false positives!

You can also create reports on the detected partial discharge. The report will mention the severity of each partial discharge and suggest corrective actions.
